IDENTIFICATION AND RECOMMENDATIONS FOR REMOVAL OF LICHEN

COLORSTEEL® prepainted steel is used in many environments throughout New Zealand. It is widely used for both roofing and cladding in a range of colours.

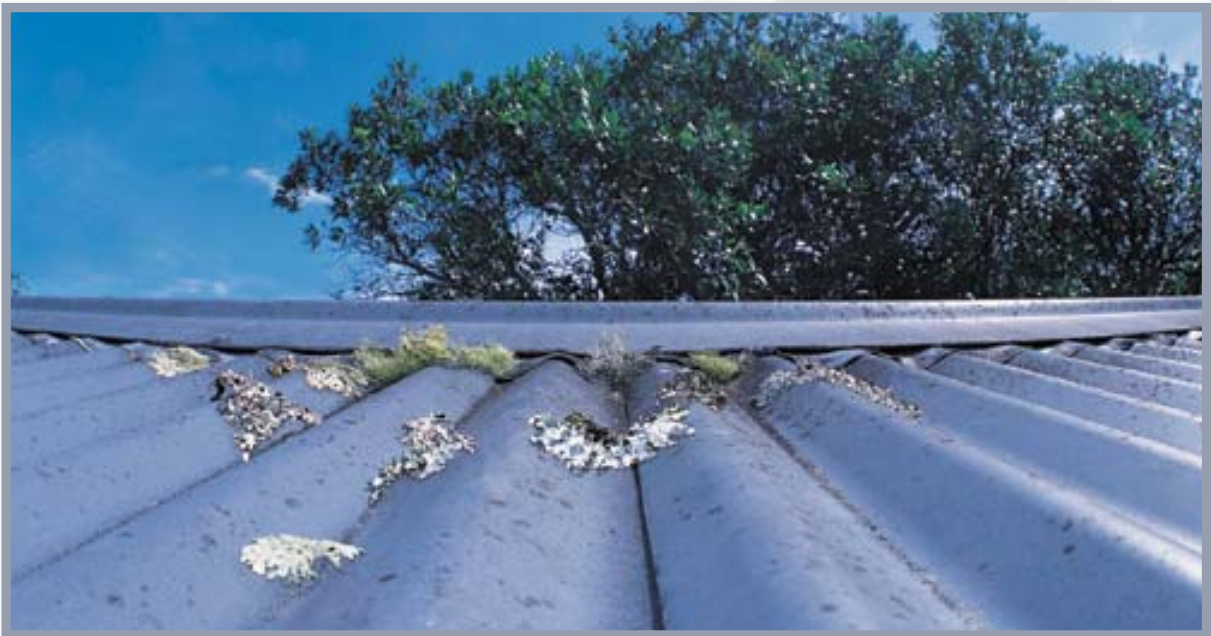
COLORSTEEL® prepainted steel paint coating may be subject to lichen growth in certain micro-environments. The temperature, dust and rainfall can create a suitable environment for the lichens to flourish.

Lichens are found almost everywhere with their spores being dispersed by wind. They are a naturally occurring phenomenon and have adapted to grow on almost every surface, from wood, brick, tiles and painted surfaces to glass and plastic. Some prefer flat to low angled surfaces, while others grow only on vertical surfaces.

To restore a roof affected by lichen or fungus, it is recommended that the roof be washed down with a 2% sodium hypochlorite solution. The sodium hypochlorite solution can be made up from commercially available bleaches.

To assist in making up the solution, Table 1 below shows the dilution required for different strength bleaches to give a 2% solution. The bleach should be applied with a soft bristle broom, left for 3-5 minutes, and washed off with copious amounts of water. A small amount of household detergent may be added to the bleach if necessary to improve wetting.
